Notes on Intel Microcode Updates

Ben Hawkes <hawkes@inertiawar.com>

December, 2012 - March, 2013

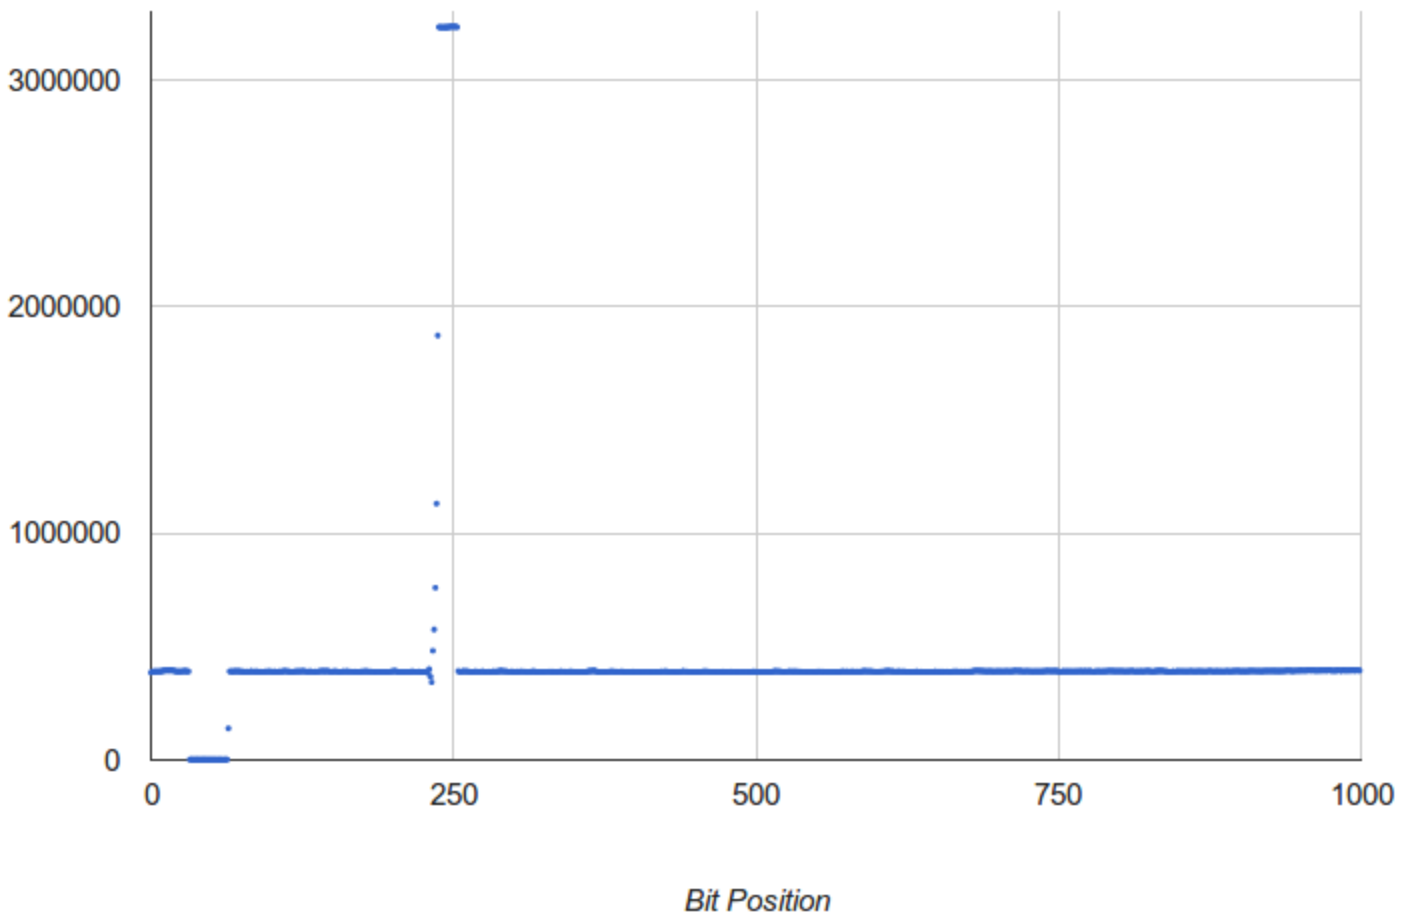
Fig 4 - Fault Injection Timing Analysis

Running this test on an Intel Core i5 M460 gives the following results:

This chart shows the results of the first 1000 bit positions being flipped. Three distinct areas of interest can be seen. All other bit position above 1000 return a cycle count matching the failure case seen above.

The first area of interest, between bit offsets 32 and 63, corresponds to an unknown word the in the 96-byte header that always has value 0x000000a1. This may serve as a magic value, checked when the microcode is first loaded to ensure that an expected format has been received.

The second area of interest is a single bit at offset 64, which appears to correspond to a flags field. In the original analysis, this bit was set. However, clearing the bit and repeating the analysis shows identical results to figure 4, except with a significantly lower average count of cycles for the "normal" failure case. The decrease in cycle count appears to be proportional to the number of physical cores on the system, which may suggest this bit is used to decide whether the update will be iteratively applied to all cores, or only applied on a single core.

The third area of interest, between bit offsets 233 and 253, corresponds to the microcode size field.
